Fire safety requirements on textile membranes in temporary building structures

Per Blomqvist, Anna Bergstrand, Nick Neumann, Ida Larsson and Per Thureson (SP)

Brandforskprojekt 305-111

SP Report 2013:30

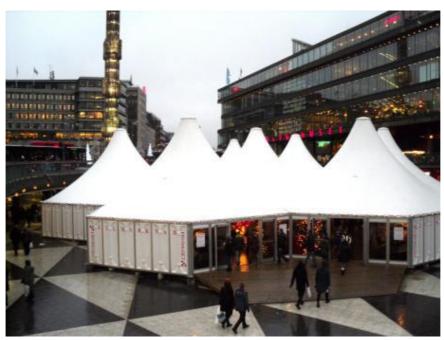
Figure 1 Tent building at the Christmas market on Sergels Torg in the center of Stockholm.

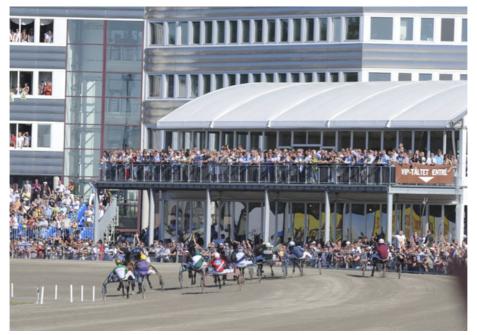
Figure 4 The two-floor textile building erected at Solvalla horse racing track.

At the horse race *Elitloppet* (in 2012), at *Solvalla horse racing track*, a two storey tent structure was raised 2-3 m from an existing office building. The tent structure was erected for a period of one week and is shown as a photo (Figure 4) and drawings (Figure 5 and Figure 6).

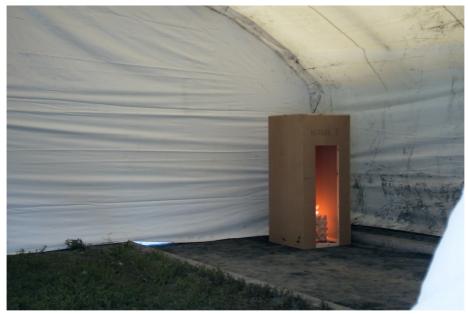
Figure 10 The fire source placed in a corner of the tent building (just ignited).

In this case SIS 650082 was not considered to be relevant due to the two layer construction. Instead, tests principally according to SP Method 2205 were conducted. In the full scale test tent, a wood crib was placed within a box of hard wood fibre (size $2 \times 1 \times 1 \text{ m}^3$) inside the tent structure as a fire source (see Figure 10 and Figure 11).

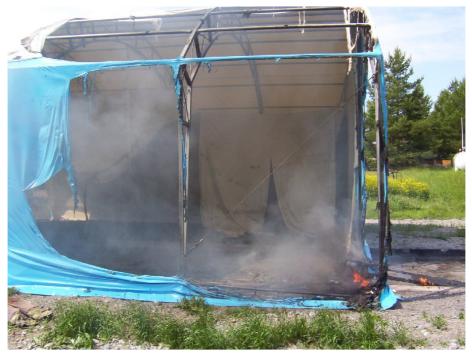
Figure 12 Damages to the test building as documented after the test.

Note that a joining cord started burning and the fire progressed far away from the ignition source.

The test run showed that the requirements in the method regarding fire spread, burning droplets and pieces, and opening area were fulfilled (see Figure 12).

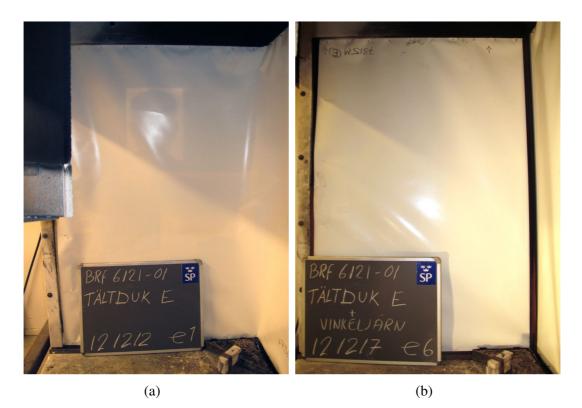
Figure 14 Mounting of the textile membrane in the SBI-test. (a) Normal standard mounting. (b) Mounting with a corner support.

A sample specimen mounted without support is shown in Figure 14 (a), and the same membrane material mounted with a metal profile as a corner support is shown in Figure 14 (b).

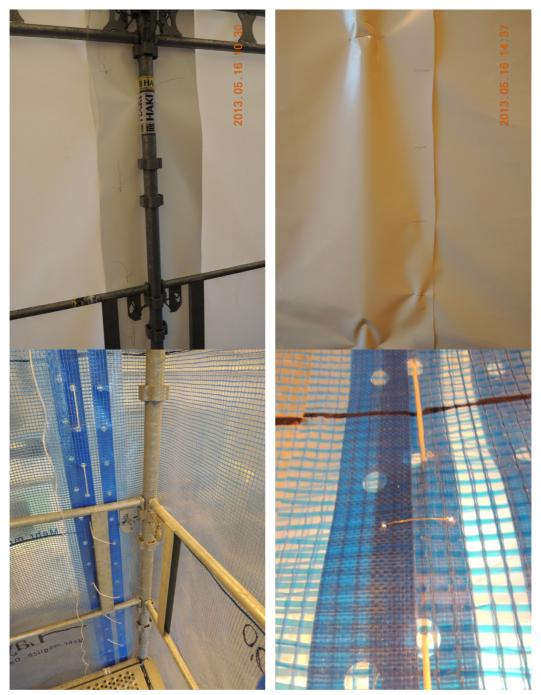
Figure 23 Techniques used to bind the sheets together and to the supporting structure (top left: binding of PVC membrane to supporting structure from the inside | top right: binding of PVC membrane to supporting structure from the outside | bottom left: binding of weather protection membrane to supporting structure from the inside | bottom right: binding of weather protection membrane to supporting structure from the outside).

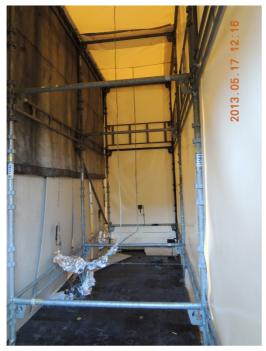
Figure 25 The thermocouple trees at position A (foreground) and position B (background) continued up to ceiling level.

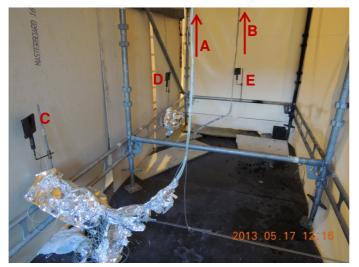
Figure 27 Thermocouple trees (position A and B) and plate thermometers (position C, D and E).

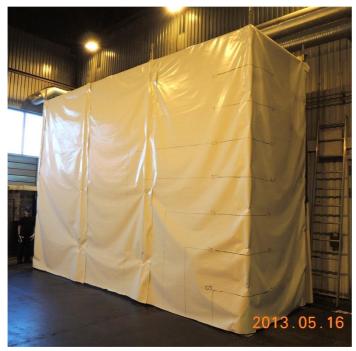
Figure 28 Markings for flame spread observations.

Vertical and horizontal markings as shown in Figure 28 were used to estimate the damaged length and the flame spread during the tests.

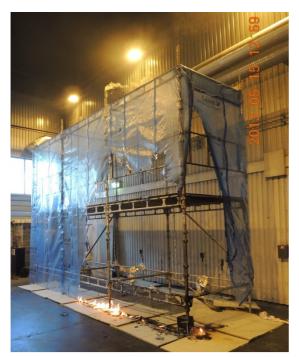
Figure 36 The test setup at the end of test and right before extinguishment.

The situation at the end of test is shown in Figure 36. The short side was damaged up to a height of about 3.5 m and a width of about 1.2 m. The damage was caused by the heat impact of the burner flame but not by flames spread. The front side was damaged up to a height of 3.3 m and a width of about 2.9 m. This damage was mainly caused by continuous flame spread. Because the flame spread also caused burning droplets a pool fire along the lower edge of the textile membrane emerged.

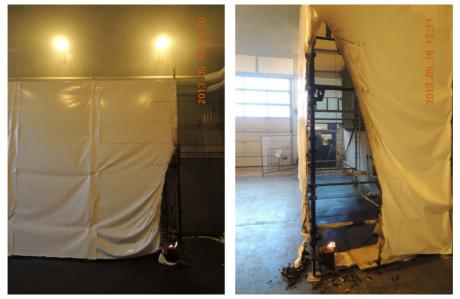
Figure 43 Fire damage of the material after the burner was turned off (left: front side | right: short side).

The front side was damaged up to a height of 2.3 m. The short side was damaged up to a height of 2.6 - 2.7 m. The horizontal damage of the front side was about 0.4 m and about 0.7 m at the short side. As shown in Figure 43, burned or partly burned material covered the floor in vicinity of the burner corner.

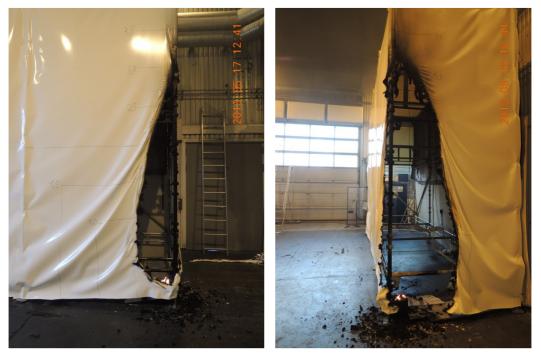
Figure 49 Fire damage of the material after the burner was turned off (left: front side | right: short side)

The front side was damaged at a height of 0.3 - 2.7 m. The short side was damaged up to a height of 3.1 m. The horizontal damage of the front side was about 0.4 - 0.5 m and about 0.7 - 0.8 m at the short side. As shown in Figure 49, burned or partly burned material covered the floor in vicinity of the burner corner.

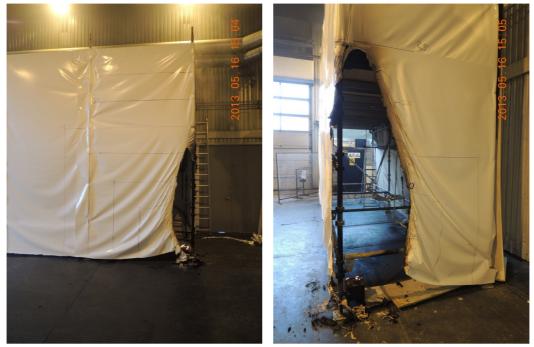
Figure 55 Fire damage of the material after the burner was turned off (left: front side | right: short side).

The front side was damaged at a height of 0.1 - 2.1 m. The short side was damaged up to a height of 2.4 m. The horizontal damage of the front side was about 0.4 m and about 0.6 m at the short side. As shown in Figure 55, burned or partly burned material covered the floor in vicinity of the burner corner.

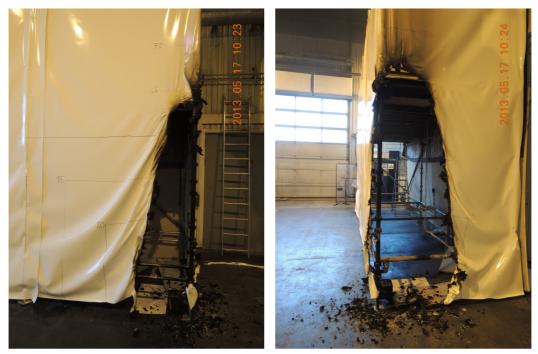
Figure 61 Fire damage of the material after the burner was turned off (left: front side | right: short side).

The front side was damaged up to a height of 2.3 - 2.4 m. The short side was damaged up to a height of about 2.6 m. The horizontal damage of the front side was about 0.5 m and about 0.8 m at the short side. As shown in Figure 61, burned or partly burned material covered the floor in vicinity of the burner corner.

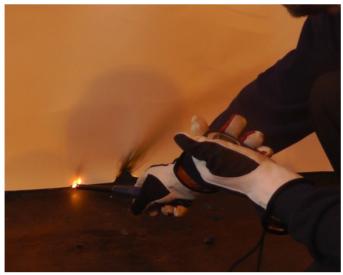
Figure 67 Ignitability tests with edge exposure.

These tests were conducted at one occasion with each membrane after that a burner test had been concluded. Ignition of the material, occurrence of burning droplets, the flame spread and the time when flames extinguished were recorded in the ignitability tests. There were no recordings made of temperatures from the thermocouple trees in these tests.

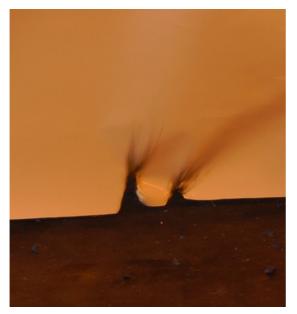
Figure 69 Fire damage after edge exposure from the outside (right: 15 s flame exposure; left: 30 s flame exposure).

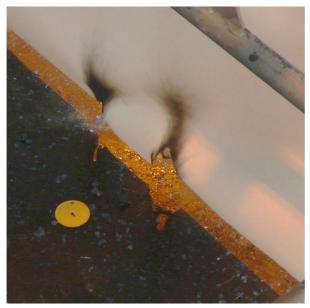
Figure 70 Fire damage after edge exposure from the inside (right: 30 s flame exposure; left: 15 s flame exposure).

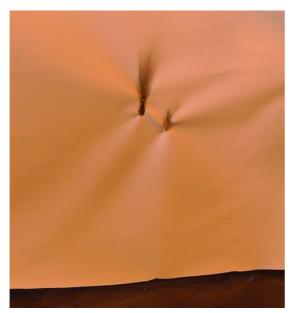
Figure 71 Fire damage after surface exposure at the outside (right: 15 s flame exposure; left: 30 s flame exposure).

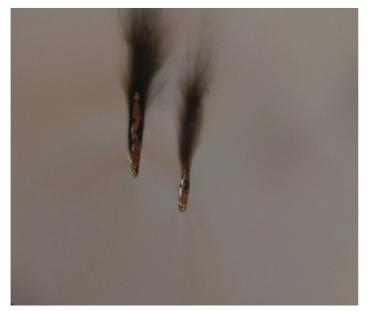
Figure 72 Fire damage after surface exposure at the inside (right: 15 s flame exposure; left: 30 s flame exposure).

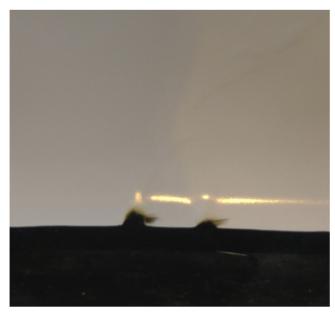
Figure 73 Fire damage after edge exposure from the outside (right: 15 s flame exposure; left: 30 s flame exposure).

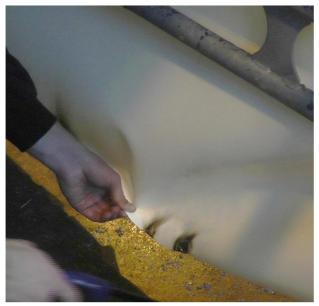
Figure 74 Fire damage after edge exposure from the inside (right: 30 s flame exposure; left: 15 s flame exposure).

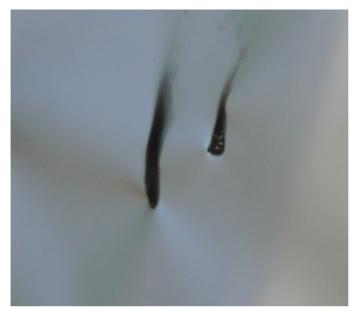
Figure 76 Fire damage after surface exposure at the inside (right: 30 s flame exposure; left: 15 s flame exposure).
