# Laboratory fire experiments with a 1/3 train carriage mockup

## Fire protection in transportation

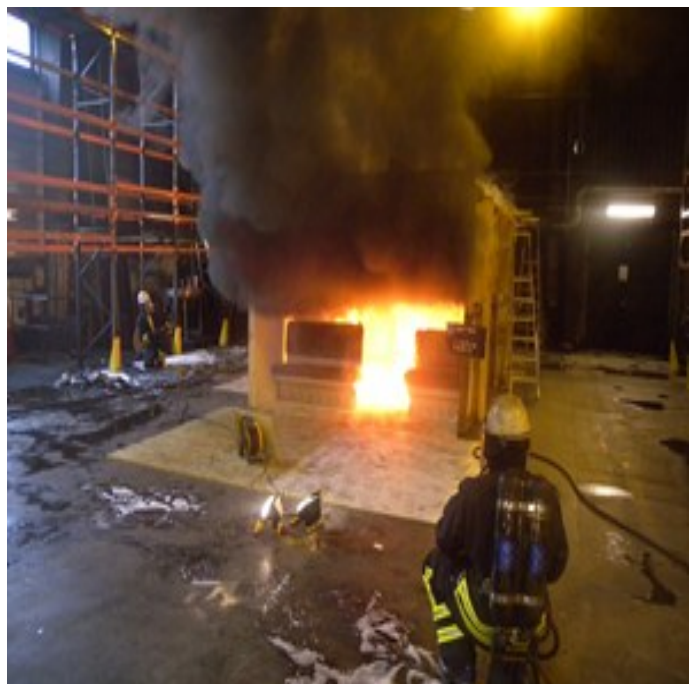
Figur 1: Bilden visar en övertänd 1/3-delsvagn i SP brandlaboratorium, foto SP.

A total of six fire tests were carried out under a large calorimeter in a laboratory environment. The ignition sources used were either wood cribs placed on a corner seat or one liter of petrol poured on the corner seat and the neighboring floor. The amount of fuel was continuously increased in order to find the limits for flashover in the test setup. The fuel consisted of wood crib piles and ordinary luggage carried by commuter travelers. The tests show the importance of the arrangement and amount of fuel. The tests also showed that the combustible boards on parts of the walls had a significant effect on the fire spread. In the cases where the initial fire did not exceed a range of 400 – 600 kW no flashover was observed. If the initial fire grew up to 700 – 900 kW, a flashover was observed. The maximum heat release rate during a short flashover period for this test set-up was about 3.5 MW. The time to reach flashover was highly dependent on the ignition type, i.e. two wood cribs with or without petrol.
